Rig Name: Monarch
Rig Type: Jack - Up
Owner name: Transocean
Classification Society: ABS
Pertinent code: Sname
Pertinent class rule: text
Code design: ASD

Project description: Some deformation has been found on the AFT drill floor skid beam on the Monarch. The underlying cause and the time frame that caused this permanent deformation are not known. Early indication from Operations suggests that this may have been formed at the time that the rig was suffering from the effect of scouring. However, there is no incident report available to confirm or give out the detailed information of this phenomenon.

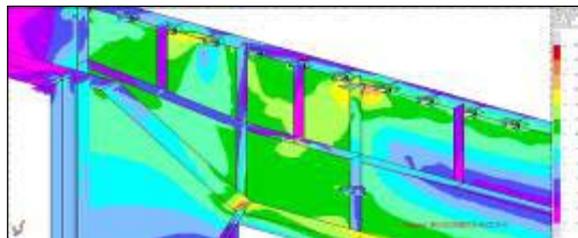
Stress Plot

In order to ascertain the extent of the local deformation and possible global deflection of the cantilever and skid beam itself, **Laser Scan Technique** was deployed to capture the images which can later on be compared with the future monitoring of this deformation. The advantage of the Laser Scan is that any deformed location can be interrogated for the net amount of distortion locally or globally by slicing the images using **LFM Server**, post processing software. This was done at Rig Engineering and the extent of deformation was reported back to Transocean.
