Rig Name: Monarch
Rig Type: Jack - Up
Owner name: Transocean
Classification Society: ABS
Pertinent code: Sname
Pertinent class rule: text
Code design: ASD

Project description: Some deformation has been found on the AFT drill floor skid beam on the Monarch. The underlying cause and the time frame that caused this permanent deformation are not known. Early indication from Operations suggests that this may have been formed at the time that the rig was suffering from the effect of scouring. However, there is no incident report available to confirm or give out the detailed information of this phenomenon.

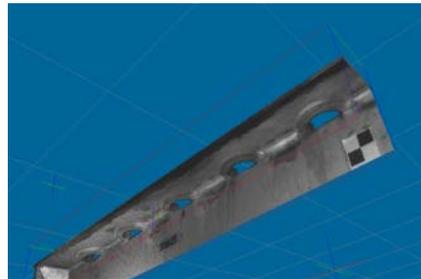
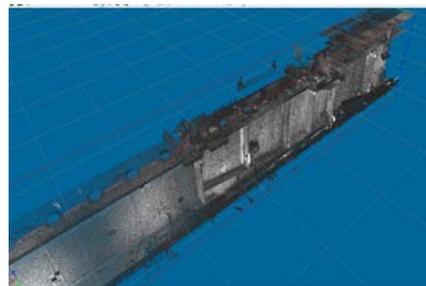
In order to ascertain the extent of the local deformation and possible global deflection of the cantilever and skid beam itself, **Laser Scan Technique** was deployed to capture the images which can later on be compared with the future monitoring of this deformation. The advantage of the Laser Scan is that any deformed location can be interrogated for the net amount of distortion locally or globally by slicing the images using **LFM Server**, post processing software. This was done at Rig Engineering and the extent of deformation was reported back to Transocean.
